**NAUGATUCK RIVER BASIN  
NAUGATUCK, CONNECTICUT**

**MULBERRY RESERVOIR DAM  
CT 00130**

**PHASE I INSPECTION REPORT  
NATIONAL DAM INSPECTION PROGRAM**

**JANUARY 1980**

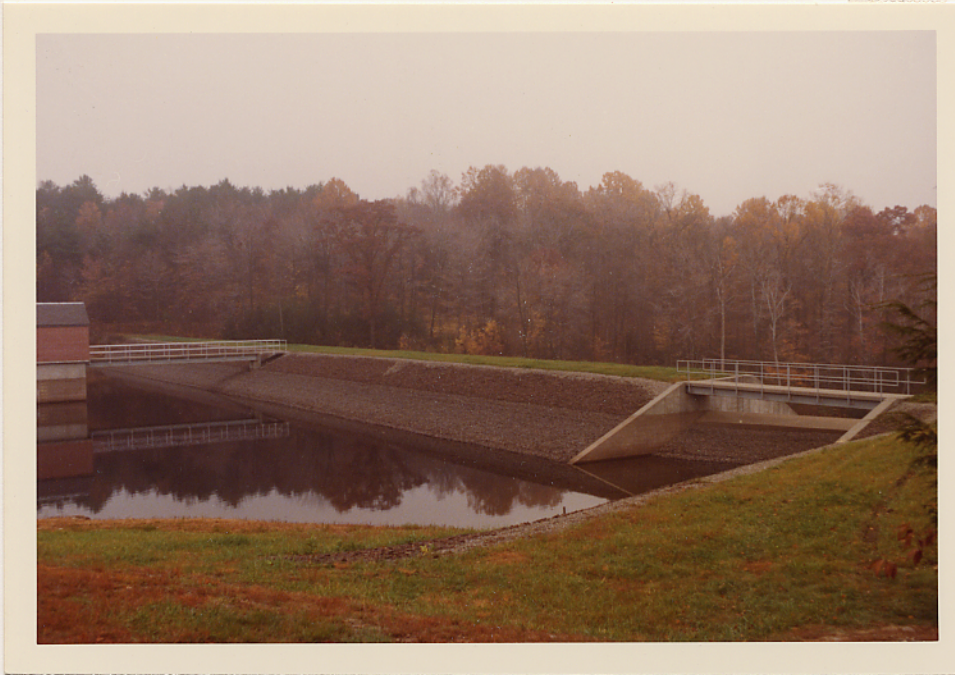
PHOTO NO. 1

The upstream slope is covered with a layer of 2 to 4-inch crushed stone riprap which was placed on a gravel filter layer. Both materials were exposed at the crest, Photos 1 and 2. The riprap is in good condition, and only minor downstream displacements could be observed near the crest, probably due to trespassing.

UPSTREAM SLOPE PROTECTION  
SPILLWAY AND GATEHOUSE

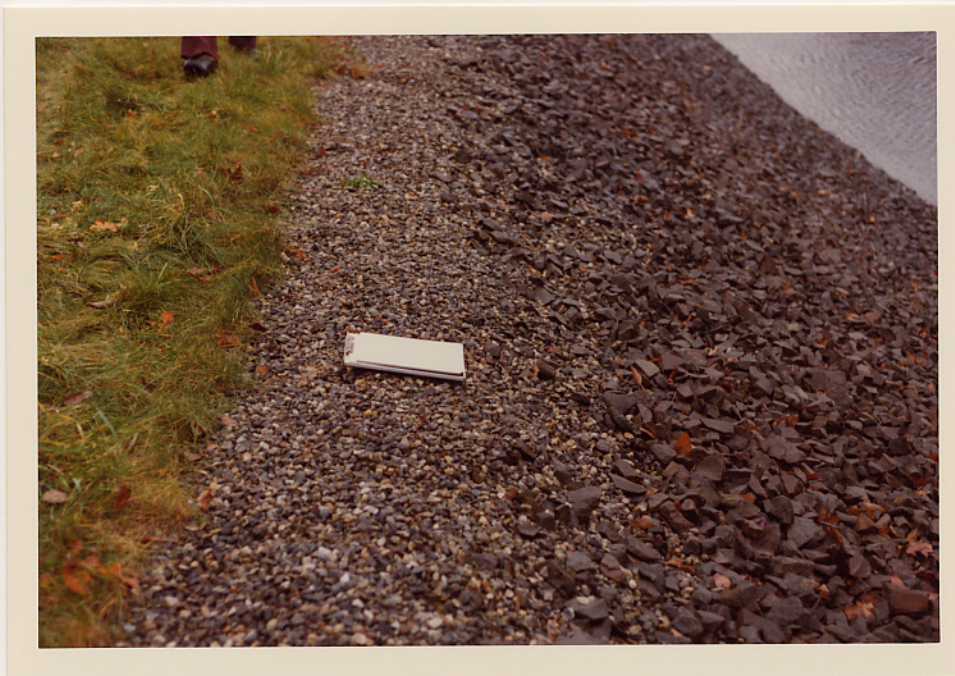
PHOTO NO. 2

CLOSE-UP OF UPSTREAM EDGE OF CREST

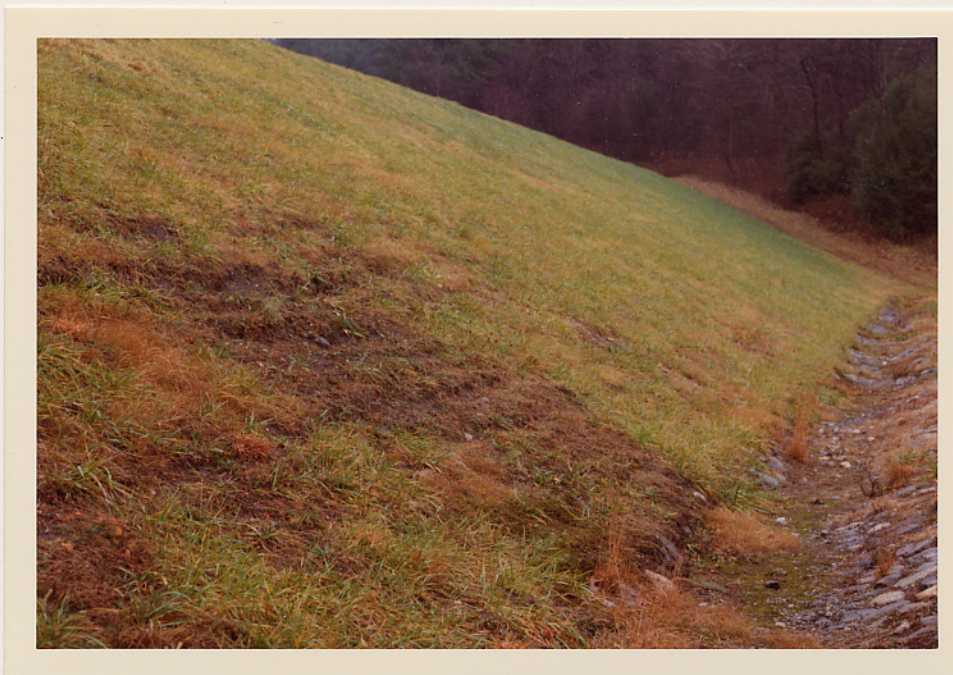
PHOTO NO. 3

AREA OF MINOR EROSION  
ON DOWNSTREAM SLOPE

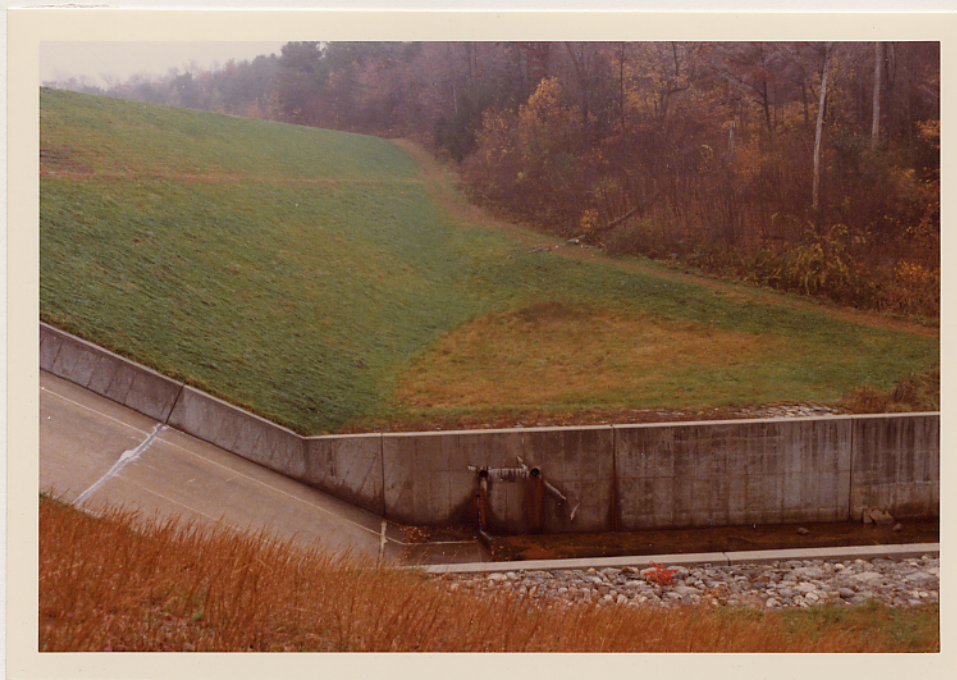
PHOTO NO. 4

Downstream of the dam there is a wet area extending from the toe to about 60 feet downstream of the toe, and between the left spillway wall and approximately 90 feet to the left of the spillway. The wet area is soft and spongy with marsh-type vegetation. Water covers most of the wet area, and no obvious flow can be observed. The water contains rust-colored floccules and occasionally an oily sheen at the surface. The wet area can be seen in Photo 4, where it can be identified by the brownish vegetation cover.

The lack of seepage out of the downstream slope indicates that the pervious shell shown in the drawings is draining embankment seepage into the drain as intended. On the other hand, the wet area downstream of the dam indicates that foundation seepage is, at least partially, passing under the toe drain and exiting downstream of the dam. Since no soil movement was observed in the wet area, this seepage does not constitute an unsafe condition at present. However, investigations are required to determine whether this condition could lead to erosion and piping in the future. The flow observed out of the toe drain of about 6 gallons per minute indicates the presence of fairly pervious soils, probably in the foundation rather than in the embankment.

WET AREA DOWNSTREAM OF DAM  
AND LEFT OF SPILLWAY

- a) Design and construct modifications to the stilling basin floor slab to prevent the development of uplift water pressure.
- b) Investigate the significance of the wet area downstream of the dam and recommend measures for monitoring the volume of flow out of the toe drain in relation to the reservoir level. A substantial increase or decrease in flow in a short period of time, unrelated to reservoir level, could indicate a potential problem. Monitoring should be done at least monthly for a period of two years and then the monitoring program should be adjusted based on the results of observations made. Measures for preventing possible piping and erosion problems should also be recommended if deemed necessary.

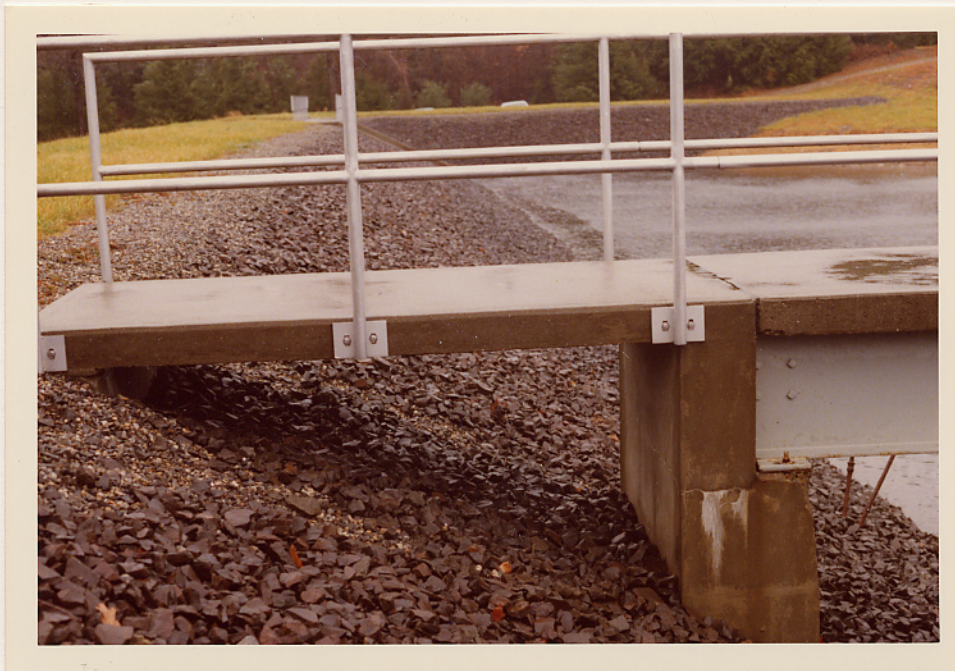
PHOTO NO. 5

The bridge to the gatehouse is generally in good condition, except for a transverse crack at the second pier from the dam, Photo 5. The visible part of the gatehouse structure is in good condition.

GATEHOUSE BRIDGE PIER  
TRANSVERSE CRACK IN PIER SUPPORTING STEEL BEAM

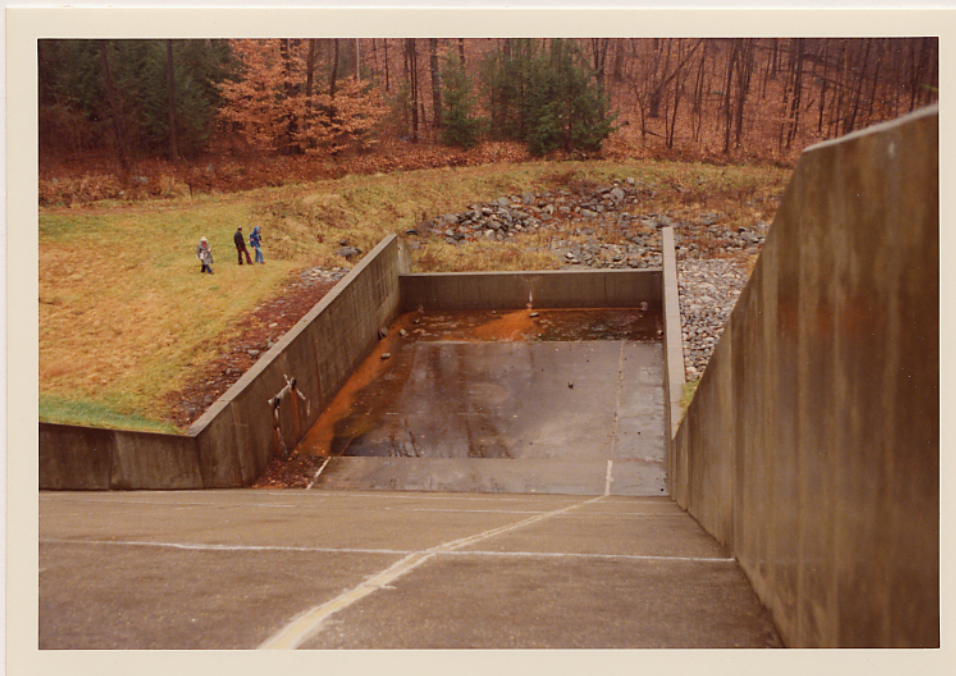
PHOTO NO. 6

The spillway is a concrete structure near the right abutment with a concrete chute and a stilling basin at the toe of the dam, Photo 6. The training walls are generally in good condition. A differential lateral movement of about 3/4 inch was observed across a construction joint in the left training wall at the crest of the dam, Photo 7. The owner's representative stated that the displacement has been observed for many years and that no change has been detected. Seepage was observed at the base of a construction joint of the left training wall at the upstream end of the stilling basin, Photo 8. The spillway floor shows repairs to the joint filler which, according to the owner's representative, have been made at different times. The floor slab of the stilling basin

SPILLWAY DISCHARGE CHUTE AND STILLING BASIN

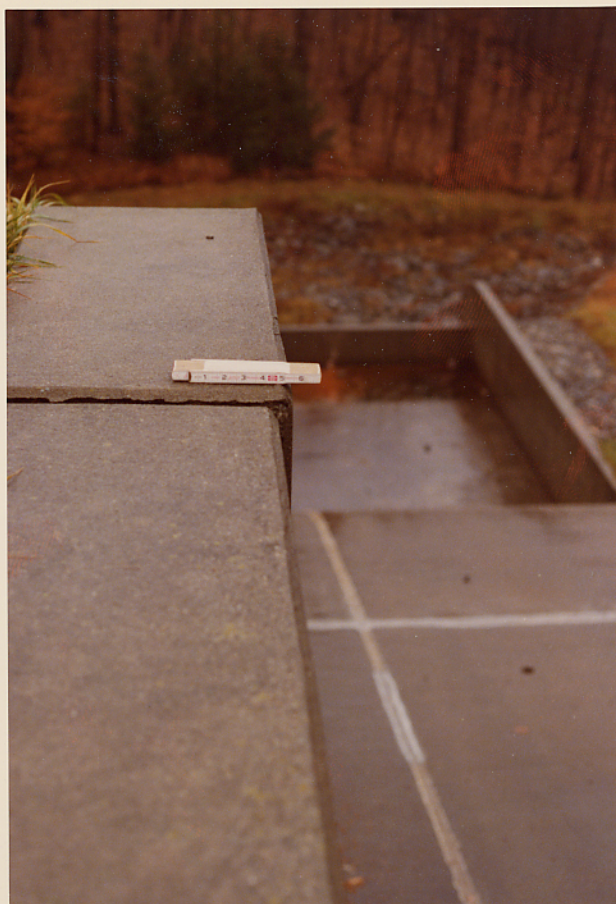
PHOTO NO. 7

LATERAL DISPLACEMENT ACROSS  
CONSTRUCTION JOINT IN LEFT  
TRAINING WALL OF SPILLWAY  
AT CREST OF DAM

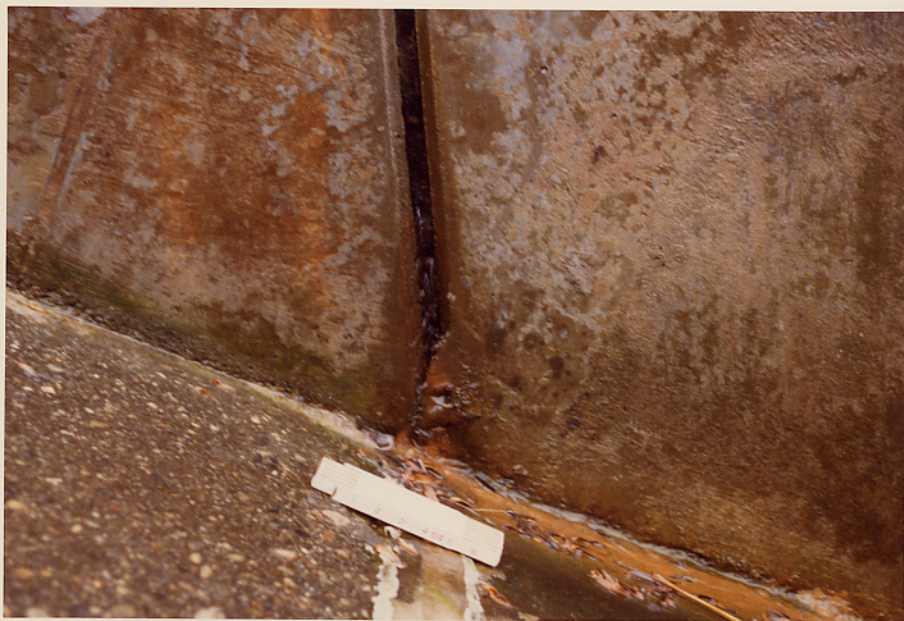
PHOTO NO. 8

The seepage into the stilling basin, both through joints in the bottom slab and in the training wall, indicates lack of appropriate drainage behind the walls and under the bottom slab. Uplift pressures under the bottom slab have apparently caused some vertical movements of the slab and further deterioration is likely to occur in the future. The design drawings indicate a transverse drainage pipe under the bottom at the downstream end of the stilling basin. No other drainage is indicated under the stilling basin.

SEEP THROUGH CONSTRUCTION  
JOINT IN LEFT  
WALL OF SPILLWAY AT  
UPSTREAM END OF  
STILLING BASIN

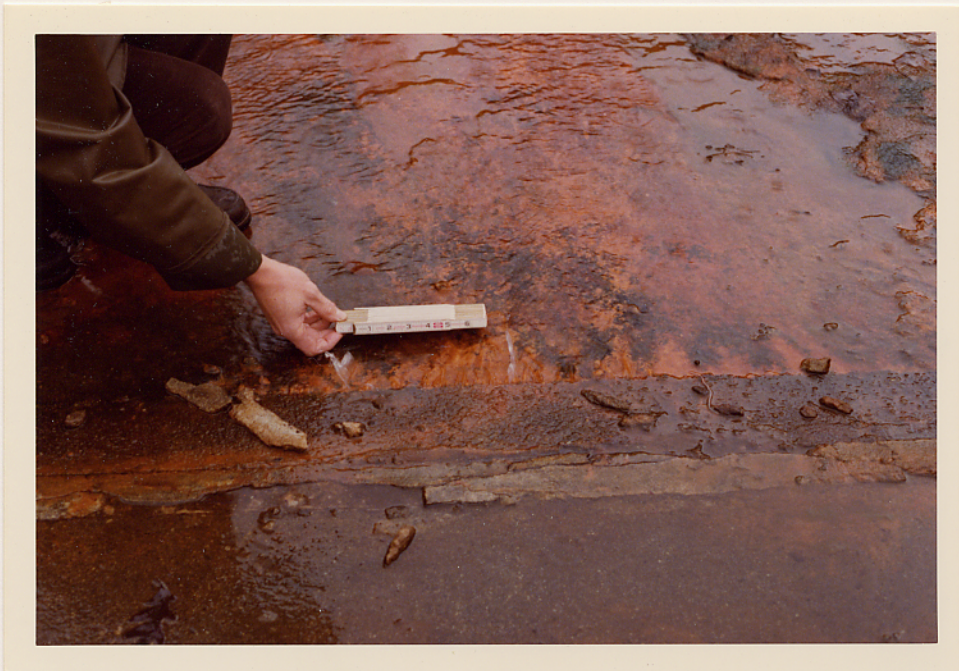
PHOTO NO. 9

shows some differential vertical movements across some construction joints, and an upward flow of water could be observed through one joint, Photo 9. The bridge across the spillway is in good condition.

WATER SEEPING THROUGH CONSTRUCTION JOINT  
IN STILLING BASIN FLOOR SLAB

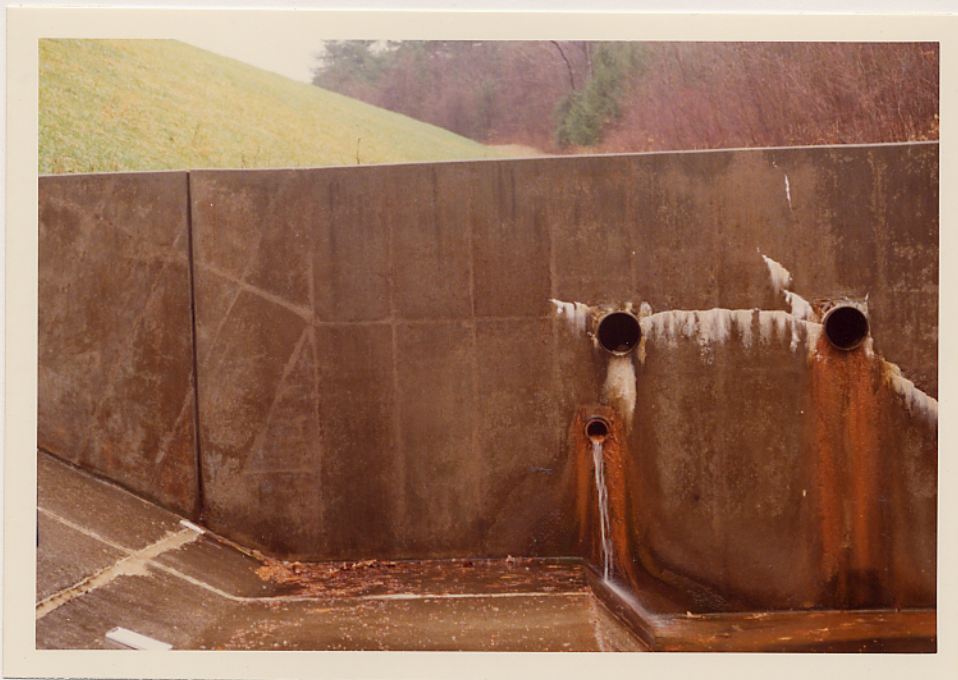
PHOTO NO. 10

A 6-inch diameter V.T. pipe and two 12-inch diameter C.I. pipes discharge into the stilling basin, Photo 10. The 6-inch pipe is the outlet for the toe drain for the dam and was discharging about 6 gallons per minute of clear water. The two 12-inch pipes were not discharging. One is the blowoff outlet, and the other is connected to the supply main. Minor cracking and efflorescence was observed in the training wall in the area of the discharge of these pipes.

OUTLETS FOR TWO 12-INCH DIAMETER PIPES AND  
DISCHARGE FROM 6-INCH DIAMETER TOE DRAIN
